Saturation Profiles in the Fracture (a) and Matrix (b) for a 300 micron Fracture With "α" Change

Figure 6-8h

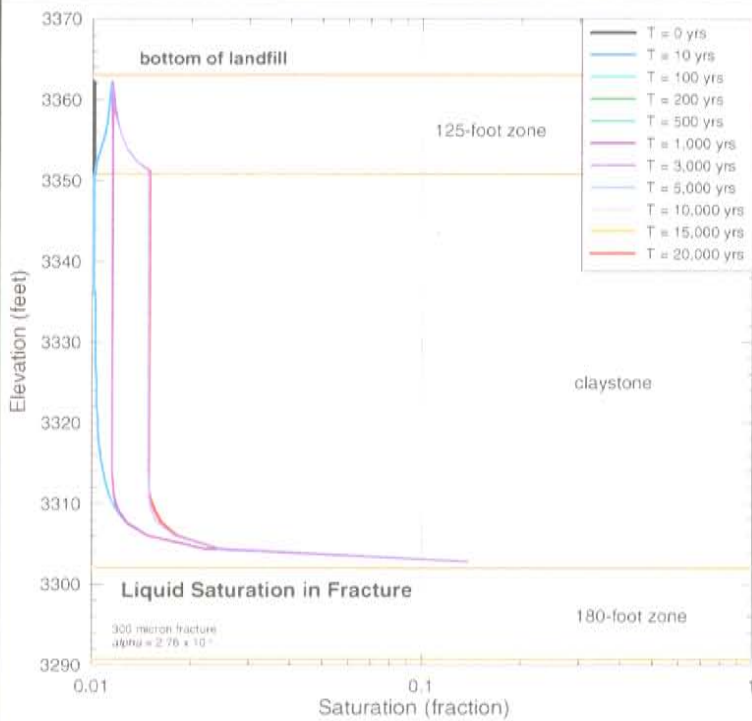
(a)

(b)
