Saturation Profiles in the Fracture (a) and Matrix (b) for a 30 micron Fracture and no "α" Change

Figure 6-8i

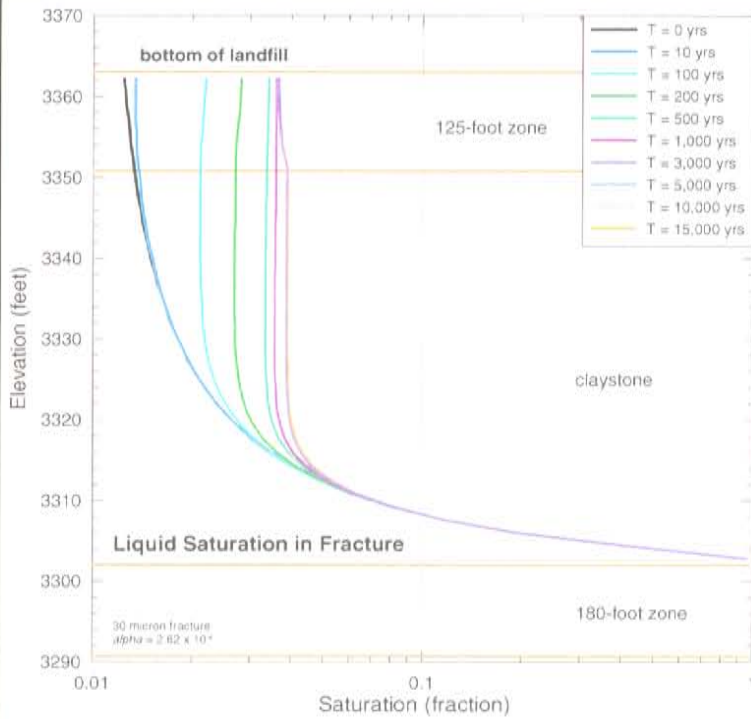
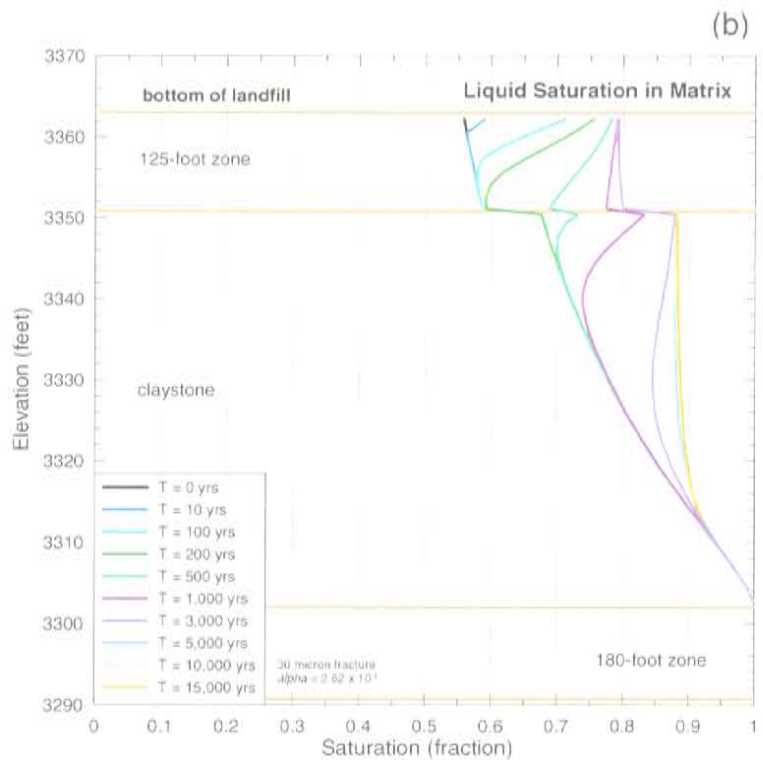
(a)

(b)
